TECHNICAL INFORMATION BULLETIN 89-11

4 ESS™ SWITCH ELECTROMAGNETIC PULSE ASSESSMENT

VOLUME 2: TASK 3 LABORATORY TESTING OF THE 4 ESS SWITCH

SCIENTIFIC AND TECHNICAL FINAL REPORT

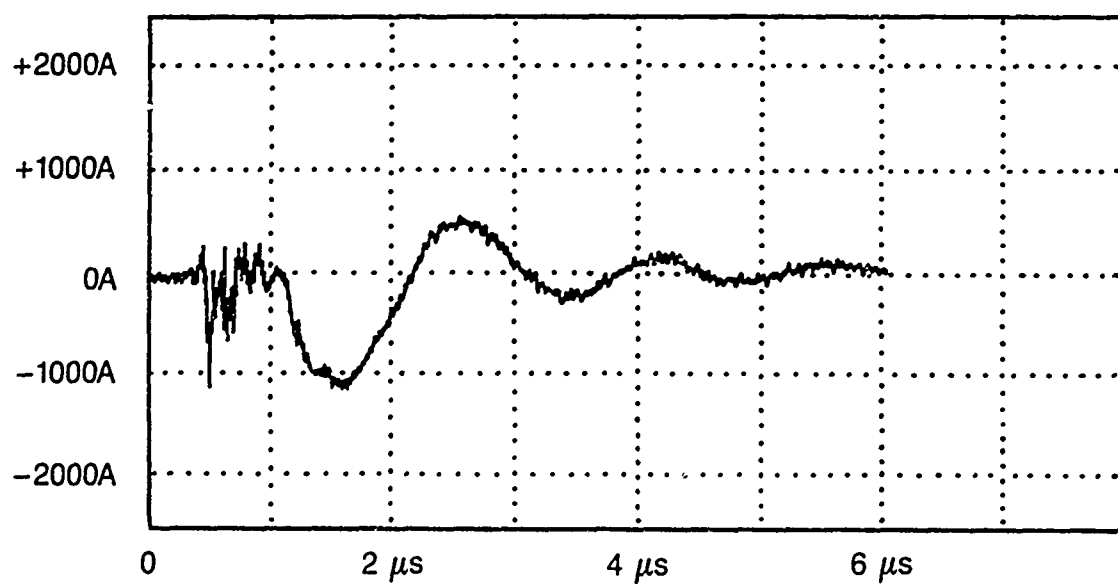
Figure 4. Current on bundle of 24 cables between PPI and MCC.

During the spark-gap tests and the large current driving tests, the cables connecting the PPI with the MCC coupled transients that resulted in the MCC being taken out of service. This occurrence stopped the MCC, the main operator/machine interface, from accurately displaying the status of the machine. Also disabled were some of the diagnostic functions available on the MCC. However, the operator could still request the machine to take a phase, i.e., a software reinitialization.

Hardware damage was noted when these transients burned out transistors driving some of the lights on the MCC panel. About 10 of these transistors were so destroyed. This damage did not prevent the proper operation of the push buttons that the lights illuminated.

To reduce sensitivity of the PPI and MCC, the cables connecting these pieces of equipment were encased in shields consisting of metallic zipper tubing.
